Tech Tip

12-0104-3

Product Affected – 2008 & Newer Vision

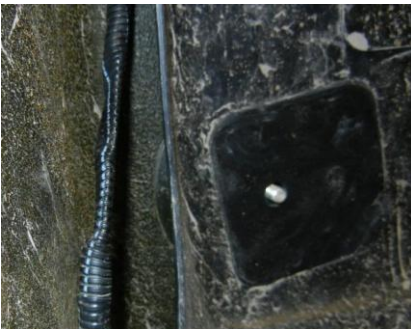
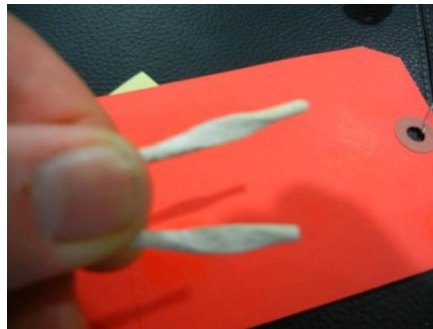
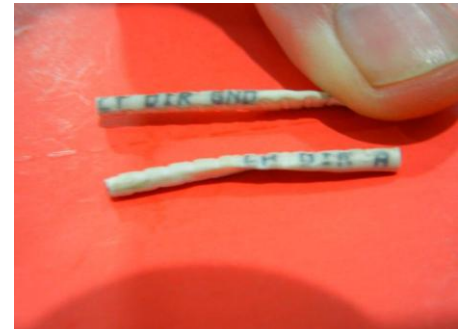
- Complaint:** The directional turn signals on the hood (Lollipop lights) do not work or work intermittently
- Cause:** During assembly the wires running to those lights were run between the inner fender and hood. If they were run too close to the mounting points then the wires could become cut (FIGURES 1, 2 &3).

- Correction:** Tilt the hood and locate the cutout for the light mounting. There could be an issue if the wire is routed back toward the main harness under the inner fender as in FIGURE #4. Locate the mounting pads and see if the wires run too close, as in FIGURE #5. Loosen or remove the mounting screws to pull the loom from under the inner fender. Pulling the loom back about 4” from the light should reveal the connectors (FIGURE #6). Placing that section of the loom under the narrow outer section of the inner fender cutout (FIGURE #7) should give additional protection from “rub-thru”. Run the loom along the outer edge of the inner fender, secure with wire ties as required.
