Tech Tip

Cummins Cold Weather Operation

(REFERENCE TECH TIP #14-0101REVA)

Fault Code 3542 Caused by Engine Intake Throttle Actuator Icing on ISB6.7 CM2350 B101 and ISL9 CM2350 L101 Engines

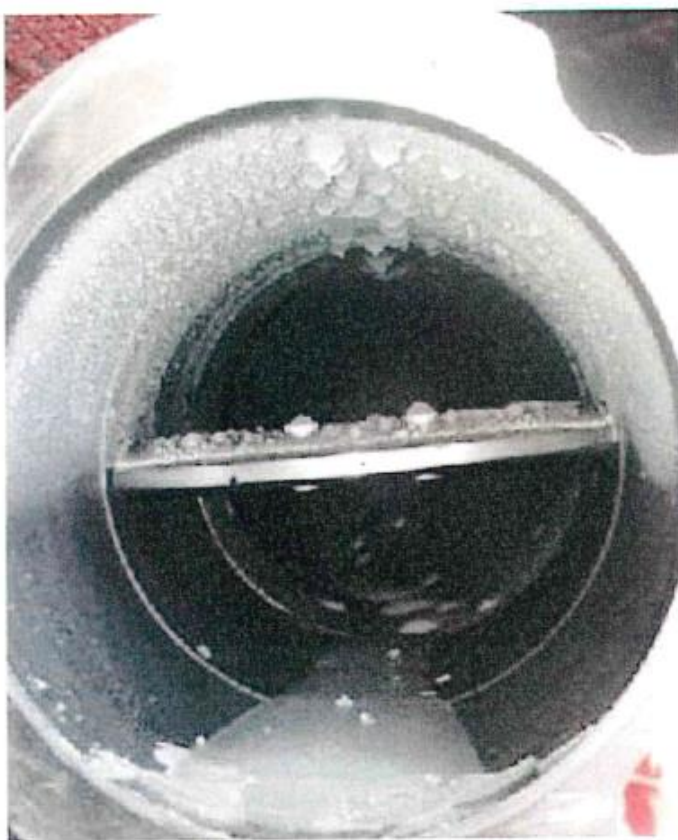
10r00087

Engine will come in with Fault Code 3542 and no trouble is found at the time of troubleshooting. During cold weather periods, condensation can form on the engine intake throttle actuator butterfly valve. Condensation can freeze when the engine is off causing the butterfly valve to stick from ice obstruction during the next period of engine operation. This ice or condensation may **not** be present during troubleshooting.

Figure 1, Ice Obstruction in Engine Intake Throttle Actuator

If no trouble is found and the engine has been operating during periods of cold weather, refer the customer to Operation of Diesel Engines in Cold Climates, Service Bulletin 3379009. A winter front is recommended. A winter front will assist in reducing the time to increase the engine compartment temperatures. This will thaw out any ice build up prior to operation of Exhaust Gas Recirculation (EGR) and engine intake throttle actuator.
