PTO Pulley

Tech Tip No. 14-0602REVA

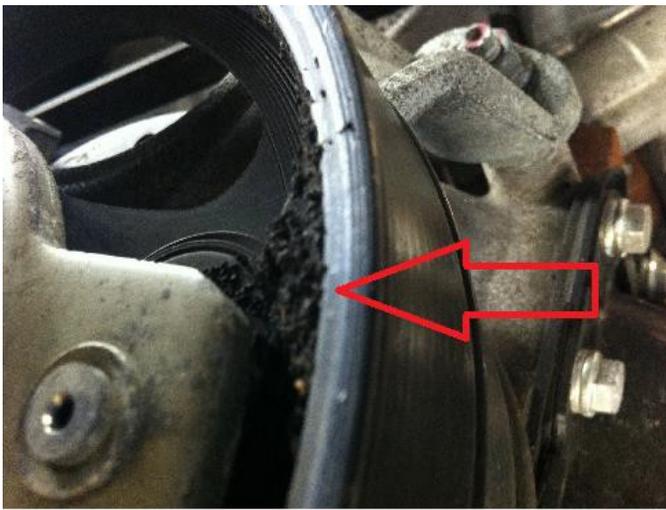
Figure #1

Complaint - There is a noise emanating from the front of the motor and on closer inspection there are “chunks” of rubber around the lower front of the motor and on the lower radiator hose (FIGURE #1)

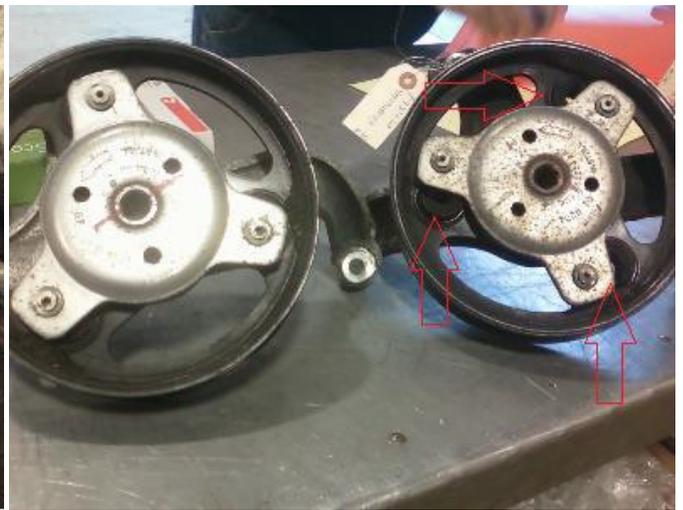
Figure #2

Cause - The pulley mounted as what appears to be a crank pulley and runs the main drive belt is mounted to its hub at 3 points which are mounted in rubber (FIGURE #2) These mounts on some units have been seen to wear and as they do the rubber comes apart. It was originally thought that the issue was only on units with A/C or with specific specifications, but has been seen on various applications.

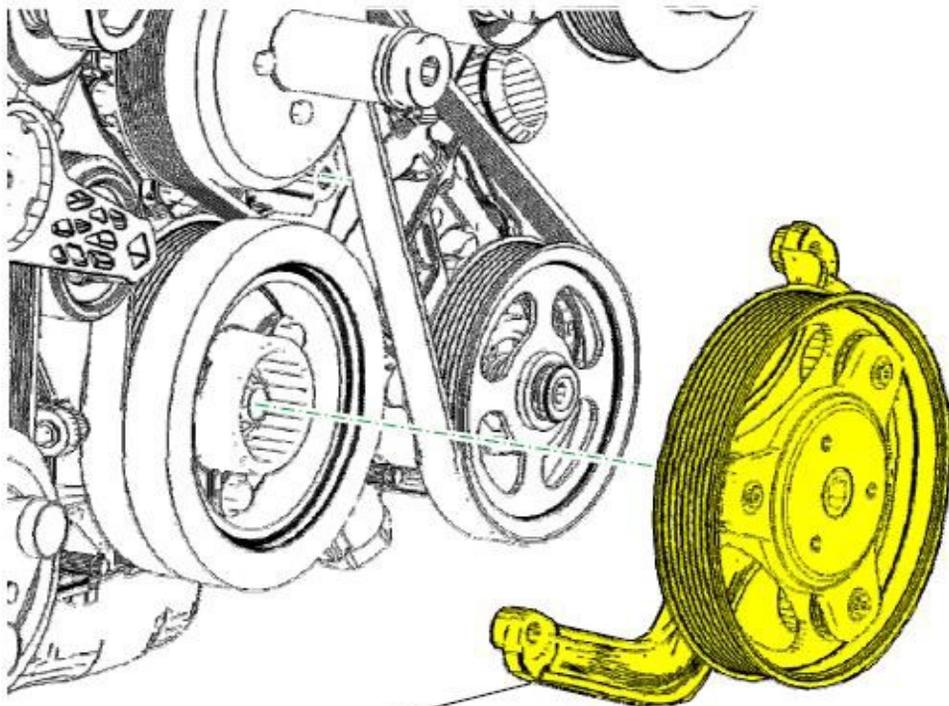
Figure #4

P11BB-6C254-A*
 PTO ASY - 2ND SHEAVE
 TORQUE: 100 +/- 5 NM
 LEFT HANDED THREAD (14MM HEX)

For installation, install the PTO on the front of the engine slipping the bracket over the lower stud to align and install the center hub bolt and holding the engine from turning torque to 100 NM (FIGURE #4). Then install the lower bracket stud nut and upper bolt and torque to 47.5 NM (FIGURE #5)

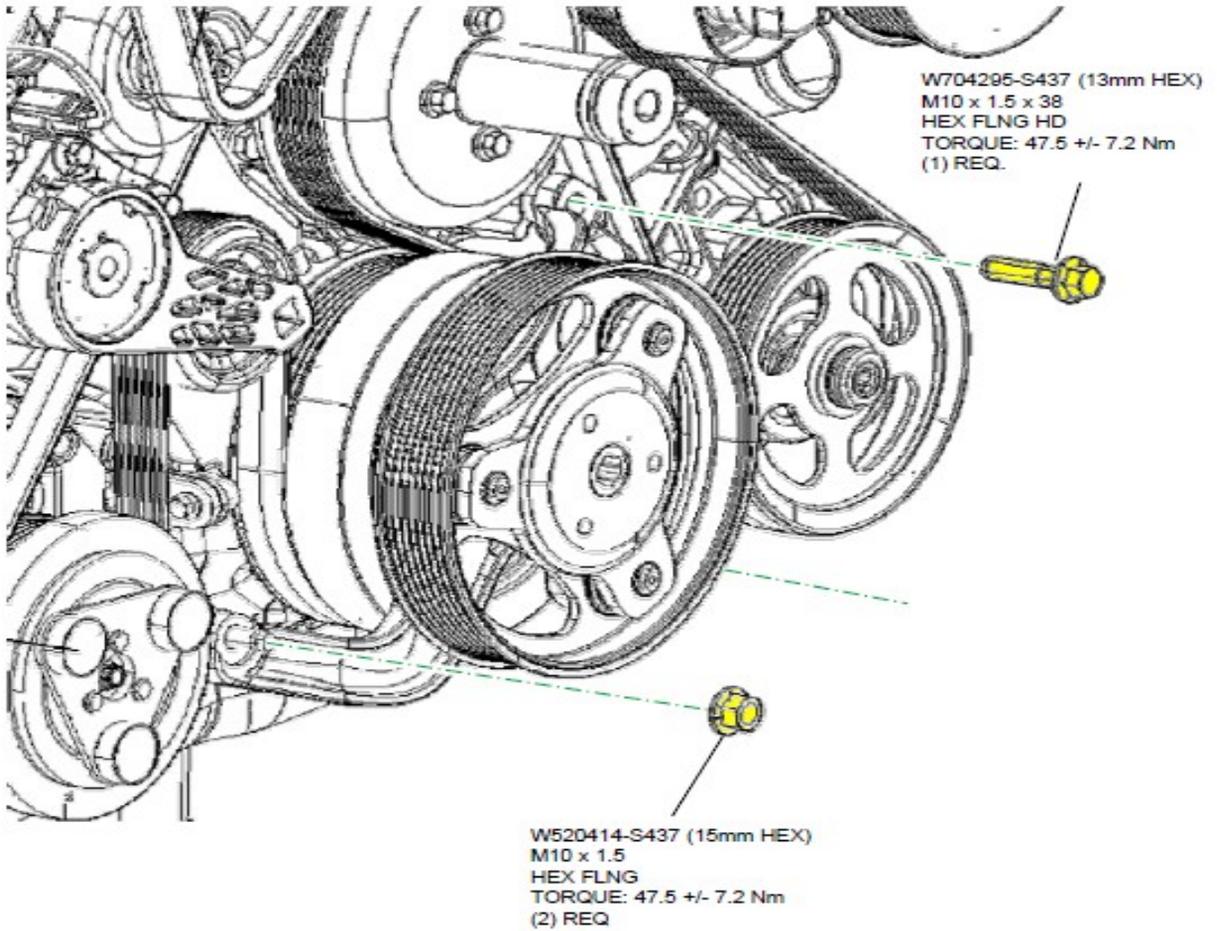
Figure #5

NOTE – Failing to do so in this manor will cause bushing damage
