Bendix Air Disc Uneven Brake Caliper Movement

Service Update #20-0923

Running Clearance Must Be Checked

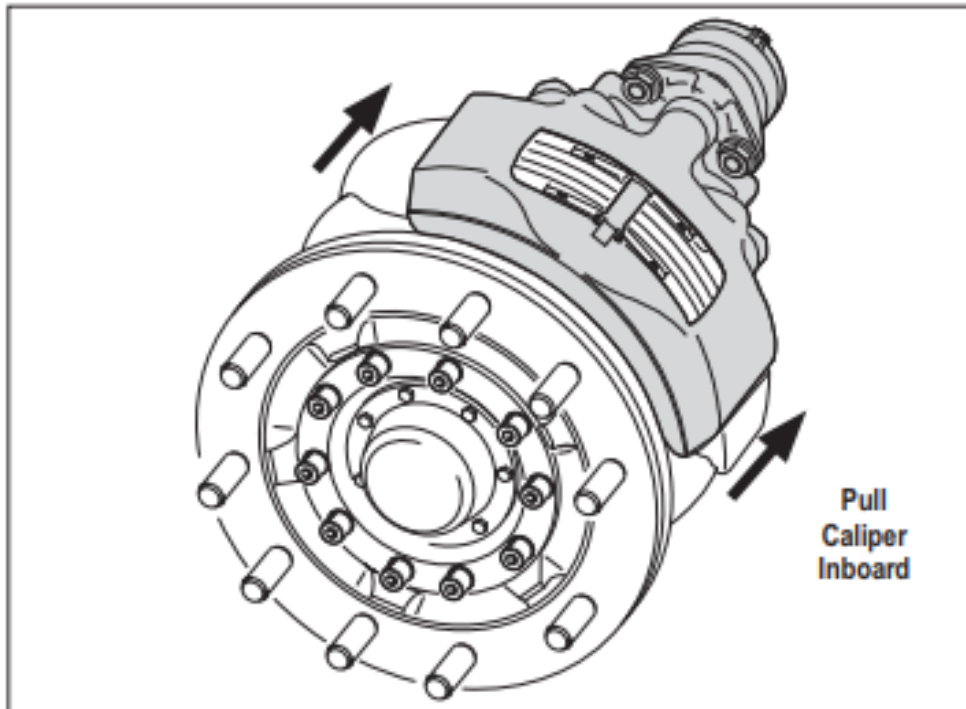
FIGURE #1a

Remove the wheel. With the spring brakes released or caged, push the caliper assembly inboard on its guide pins. *Note: To fully release the spring brakes, assure that the air system pressure is at least 90 PSI.* Using a suitable tool (for example a large flat-blade screwdriver), press the inboard pad (12) away from the tappets. Check that there is no dirt, etc. in the gap, and clean if necessary. Then use two long-blade feeler gauges to measure over the whole tappet surface the gap between them and the inboard pad backplate. (See Figure 16.) The gap should be between 0.024 in. (0.6 mm) and 0.043 in. (1.1 mm). **If the gap is within the range given, the test is complete.**

FIGURE 15 - PULL CALIPER INBOARD

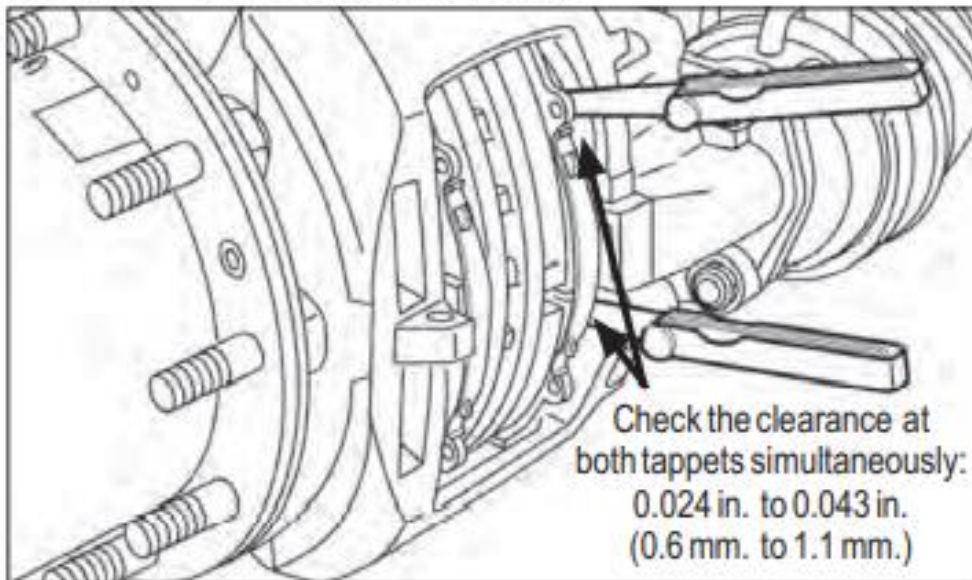
FIGURE #1b

FIGURE 16 - RUNNING CLEARANCE CHECK

CAUTION: If the clearance is too wide, there is a danger of brake failure. If the clearance is too small, or if there is no gap at all, there is a danger of the brake overheating. These conditions must be corrected before returning the vehicle to service.

For further investigation, where there is some gap, go to Section 4.2 and check the adjuster mechanism. Where there is no movement at all (and so no gap to measure), go to Section 4.5 "Guide Pin Inspection."
