Tech Tip

12-0105-2

Product Affected – Monobolts

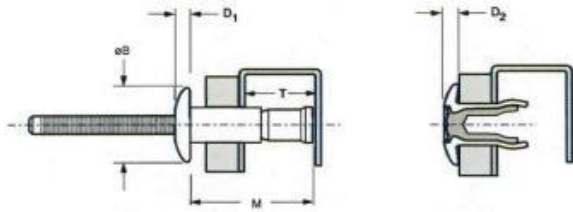
Complaint: The center pulls through the body of the monobolt or breaks off on the monobolts we are installing.

Cause: There are several conditions which can cause this

- The tip on the gun being used may be worn
- An improper sized monobolt being used
- Improper gun tip being used
- Material too thin for the monobolt

Correction: Figure #1 shows a chart indicating the minimum and maximum material thickness (**OUTLINED IN RED**) as well as the minimum and maximum drill size (**OUTLINED IN GREEN**). Figure #2 shows the gun tip and where to monitor for wear. Figure #3 shows how that section of the tip works to essentially “lock” the stem into place. A regular rivet gun does not produce this affect and should not be used with monobolts. Figure #4 shows how the installed monobolt can be checked visually for the locked stem.
