Tech Tip

From your friends at New York Bus Sales

Product Effected – Blue Bird Type C&D

Complaint - The unit appears to have a fuel leak at the tank -

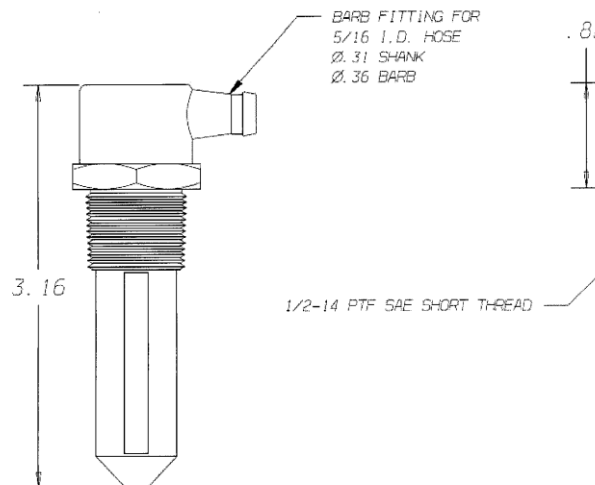
Figure #1

There was a new style vent that was used in production which is pictured in Figure #1, this vent contacts fuel at a lower level than the first production vent which is shown in Figure #2. If you look at the design of the tank, especially those “mid-mounted” in the frame even if the “first-click” method is used in fueling the tank it will allow the tank to take on more fuel as there is a 2-1/2” fuel fill line from the tank to the fuel fill which needs to be filled with fuel before it will “clock off”.

This higher level also causes the tank to allow fuel to be released from the vent line which would appear as a fuel leak.

NEW TANK VENT #00066606

Correction Once you are sure this is the location of the leak you should pull the vent and inspect. The “new” style vent should be replaced with the “old” style vent. In changing the vents you are raising the fuel contact point of the vent which if the first click method is used will cause no problems with a vent line leak.

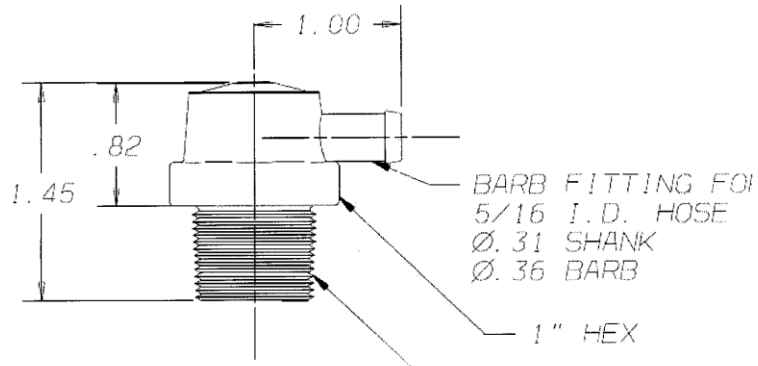
Figure #2

OLD TANK VENT
#01237072

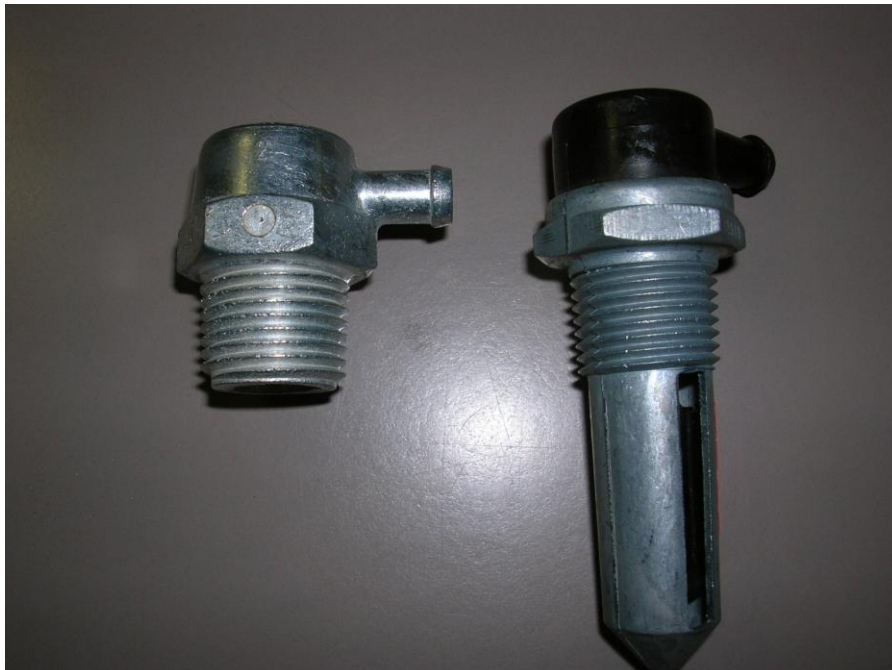
UPDATE – April 4, 2011 – Region 4 DOT today brought to our attention that the new style (Part #00066606) also has an issue with separating – As you can see in Figure #3 the material make up of the 2 vents is very different.....the old style is a single “cast” piece which is less affected by elements where the new style has potential for corrosion to cause the plastic cap to be forced off the main body as in Figure #4 and be ineffective.
