Tech Tip

FROM YOUR FRIENDS AT
NEW YORK BUS SALES!

BBCV (Vision) Steering Wheel Movement

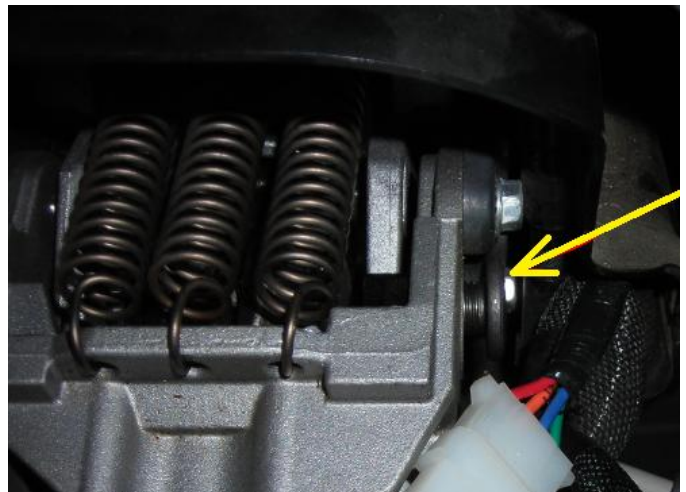
Figure #6

- #4 – Using a torque wrench and Hex socket, set the torque to 18 to 21 Nm on all 3 bolts.
- #5 – There has been at least one instance where a bolt backed out to a point where threads could be seen (Figure #6)

- #6 – If you have an instance where you see this, the bolt should be reinstalled rather “freely” until it is seated. If there is any suspicion of damaged or crossed threads, it may be best to replace the column. The manufacturer does not require the use of Locktite nor do they say it cannot be used. If you see a bolt which has backed out to the point of threads showing, New York Bus Sales would recommend using Locktite.
