Tech Tip

BLUE BIRD VISION

POWERED by ROUSH PROPANE

“PTO” Pulley Failure

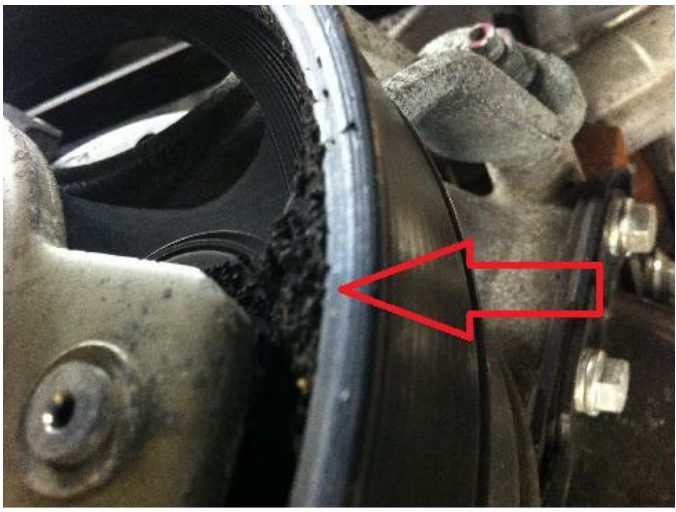
FIGURE #1

Complaint - There is a noise emanating from the front of the motor and on closer inspection there are “chunks” of rubber around the lower front of the motor and on the lower radiator hose (FIGURE #1)

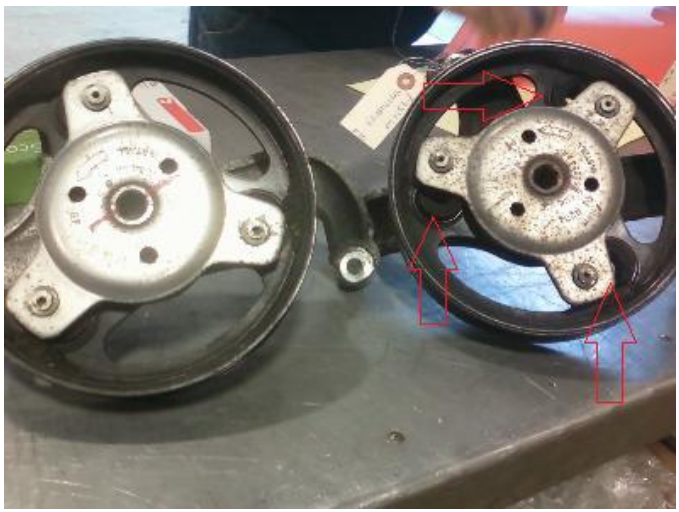
FIGURE #2

Cause - The pulley mounted as what appears to be a crank pulley and runs the main drive belt is mounted to its hub at 3 points which are mounted in rubber(FIGURE #2) These mounts on some units have been seen to wear and as they do the rubber comes apart. It was originally thought that the issue was only on units with A/C or with specific specifications, but has been seen on various applications.
