New "NextGen" Seat Flip Operation SERVICE NOTICE #17-1011REVB

All "Flip" Seats Other Than SED Seat Require Tool

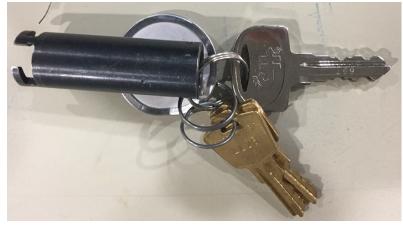
FIGURE 1

Each unit will be delivered with a tool on the key ring as shown in FIGURE #1. Additional tools may be purchased through our Parts

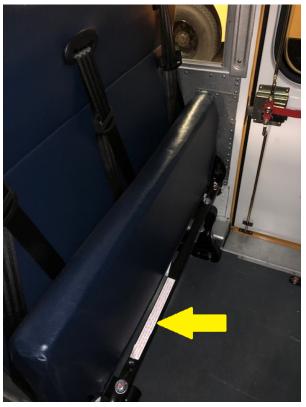
UPDATE 11-8-18 – It was brought to our attention that the warning label shown in Figure #2 is on some seats mounted at the side emergency doors. (Figure #3)

We are asking customers to check their units and remove the warning if they are present.

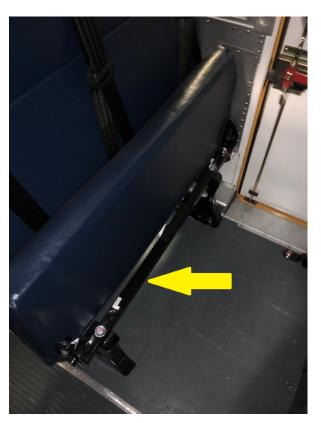
Figure #4

Seeing as these seats have the lock mechanism removed and a shock installed to keep the seat cushion in the raised position to maintain a clear path to the side emergency door, this warning should NOT be present. (Figure #4)
