Tech Tip

BLUE BIRD VISION

Air Compressor Coolant Lines Rubbing

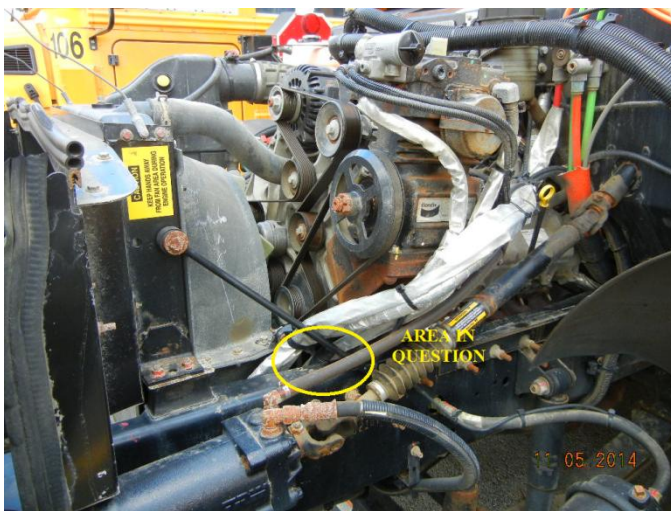
Complaint - There is a coolant leak at the left front of the engine compartment

Cause - Coolant lines to the air compressor appear to be leaking

Correction - Looking above where the leak is the area in question is shown on FIGURE #1 you can see that there are 2 hoses which are wrapped in spit loom and run along the frame rail as shown in FIGURE #2. There are several options which we are all aware of to address this such as putting a section of hose on the frame rail or putting a larger hose over the loom. As you can see in FIGURE #3 we have tied the hoses back with a zip-tie which is another option. Since finding this issue, we have found that Blue Bird is routing the hoses differently and that is shown in FIGURE #4.
