# Tech Tip

## Flip Seat Belt Cover

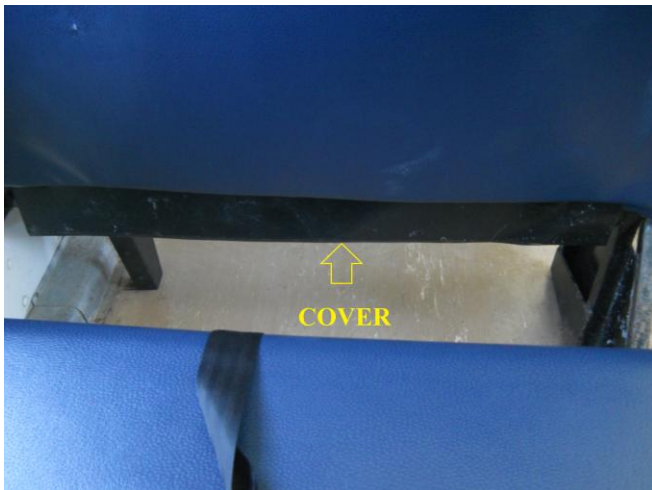
Figure #1

- Complaint –** A child’s legs/feet were injured sitting in the seat behind the flip seat
- Cause –** The cover which screws in place (Figure #1) and is designed to cover the seat belt mounting bolts and to keep the belts from falling on the floor has become bent from when it was initially installed causing some exposed sharp edges. See Figure#1 & #2
- Correction –** There are 2 fixes that can be done –  
#1 – The cover can be removed and the screws which secured it reinstalled in the seat frame – Figures #2 & #3  
#2 – The cover can be removed, straightened and “edge guard” installed along the lower edge to cover the sharp edges – Figures #4 & #5
