# Tech Tip

## Product Affected – All American “A3” Units

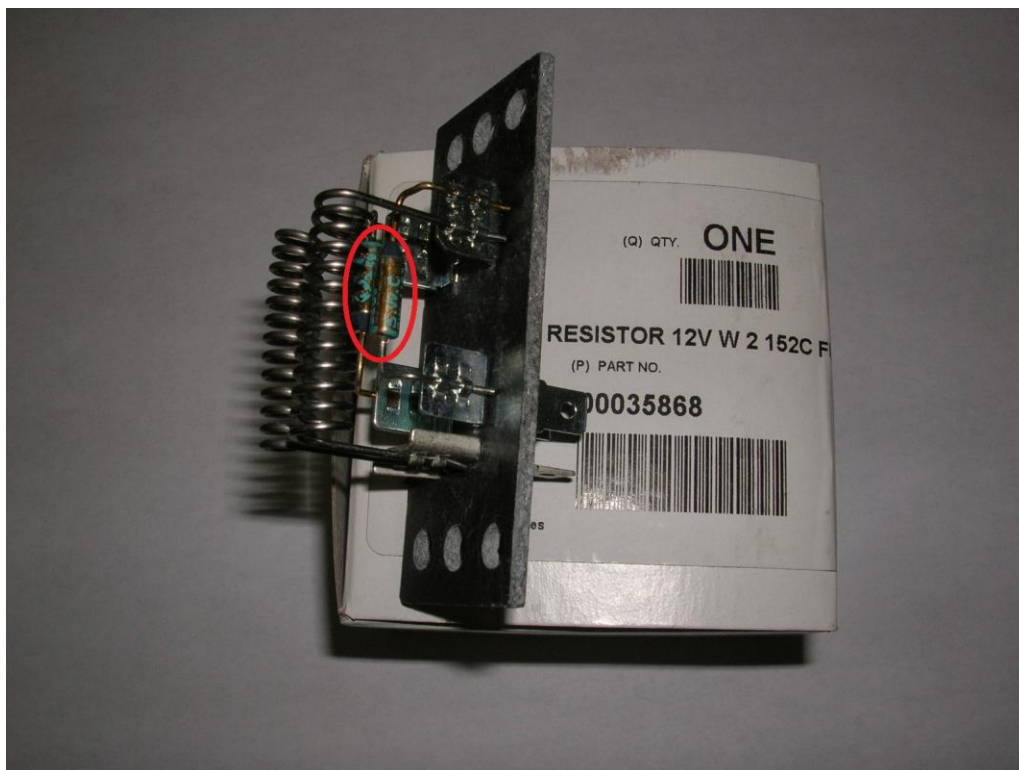
**FIGURE #1**

***IN-CORRECT RESISTOR #00035868***

**PLEASE NOTE – The resistor with the diodes may be used in an emergency but to help increase the longevity the diodes should be bent down toward the mounting plate and away from the coils ..... this should ONLY be a temporary repair!**

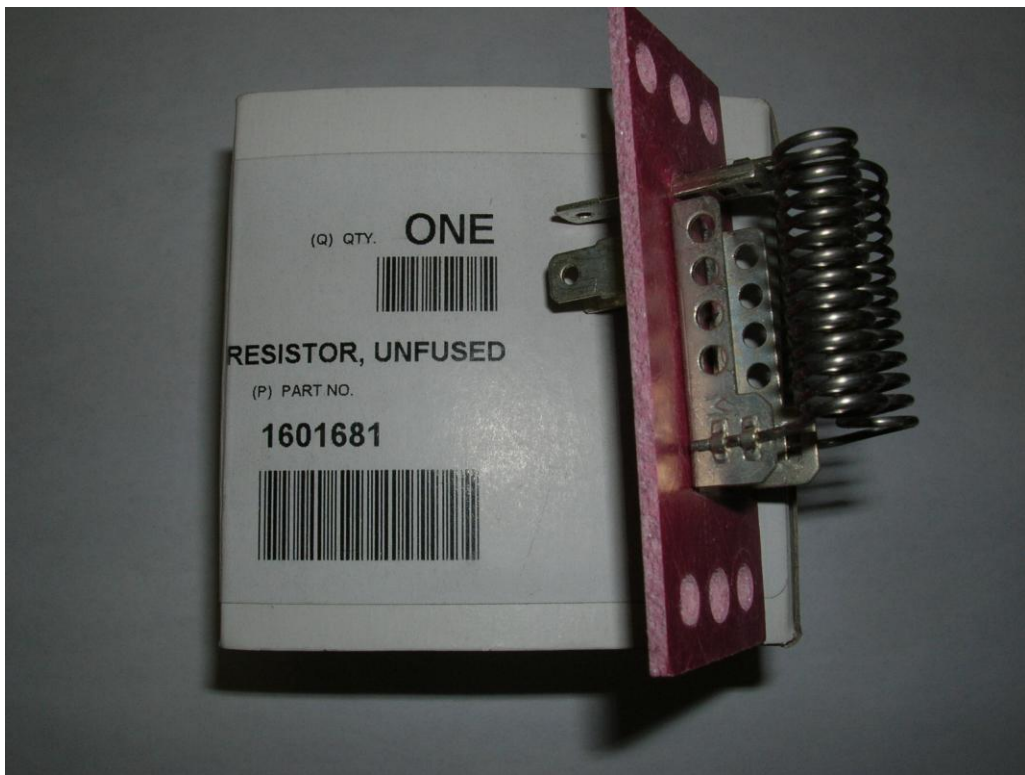
FIGURE #2

***CORRECT RESISTOR #01601681***

- Complaint -** The defroster fan only works on high, replacing the resistor works for a short time on all speeds and then fails again. Checking draw and the circuit does not show an issue.
- Cause -** Using the improper resistor – There are 2 resistors which are very similar in appearance and the only way to really tell them apart is that the improper one (Figure #1) has 2 diodes built into it and is used mainly for the rear “wall” mounted heater.
- Correction -** Use the proper resistor (Figure #2) which does NOT have the diodes -
