Tech Tip

Blue Bird BBCV-Vision

- Complaint –** We have developed an issue with our engine where there is excessive crankcase pressure.
- Cause –** There are MANY issues which could case this but the basic issue is that pressure from the cylinders is getting into the base....could be a worn or cracked ring and it “could” be from dirt ingestion!

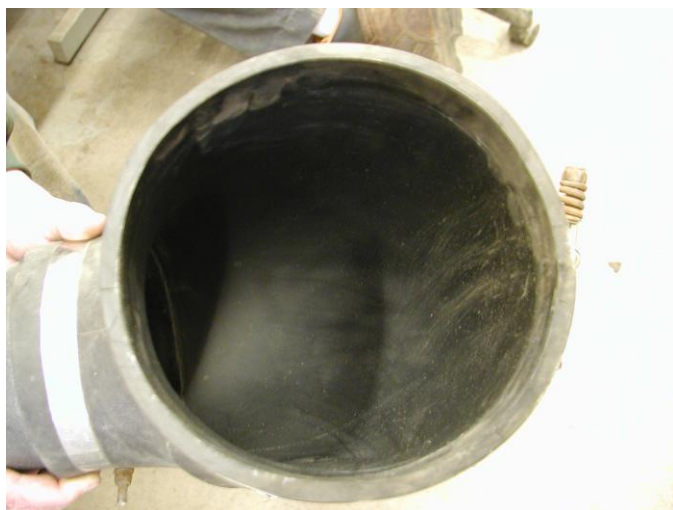
- When we have seen an issue with “dirt ingestion” or “dusting” it has been from the “air intake” portion of the system. Looking at Figure #1 you can see the dirt around the neck of the elbow and if left long enough the charged air portion of the system will show the dirt as well.....see Figure #2.

- The first recommendation would be to “NOT” depend on the “Air Restriction Indicator” to tell you there is an issue or the air filter needs to be changed as in doing so if you were to miss when the indicator got to a “vacuum” and something in the system such as the filter were to become compromised causing dirty air to be allowed into the engine. Next would be to periodically check the clamps circled in red for the proper “fit” and torque so that dirt is not allowed into the system.

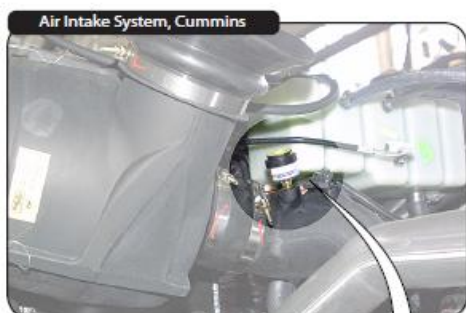
Figure #3

- Figures #3 (BBCV) and #4 (T3FE) show the air filter set up and #3 actually shows where the restrictor is located.
- Figure #5 shows the layout on a BBCV including the charged air system (Please Note that it does NOT indicate the clamp to the air intake which would be on the elbow where the “Air Restriction Indicator” is located). Figure #6 shows the layout of the air intake of the T3FE and #7 shows the charged air layout on the T3FE.
