Tech Tip 16-0105-1

2008/Newer BBCV – “VISION” Hood Repair

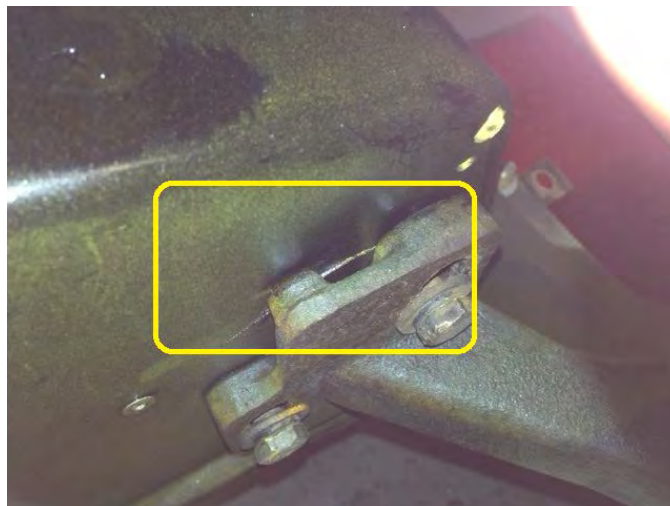
Figure #1

Complaint – The hood seems “loose” when opened. We are seeing de-lamination and “splitting” where the hood pieces are glued together.

Cause – We believe that smaller “cracks” actually start in the hinge area of the hood (Figures #1) and if not addressed over time with the opening of the hood for pre-trips etc., especially where wind can catch the hood and push it past it’s normal operating range. If this is not addressed early enough the added flex will allow other areas to de-laminate

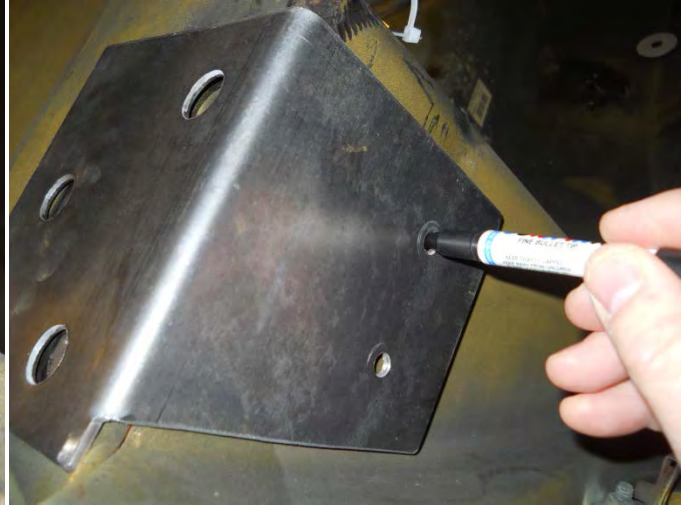
Figure #4

Taking one of the plates, align the hinge bolt holes and holding the plate in place mark the spot where the 2 smaller holes are on the upright of the hood (Figure #4). Removing the plate and using a 9/32” drill bit, put 2 holes where you have marked. Follow the same procedure on the opposite side. Using an impact gun run the 5/16” X 1” “PK” bolts into the holes to thread them and remove.

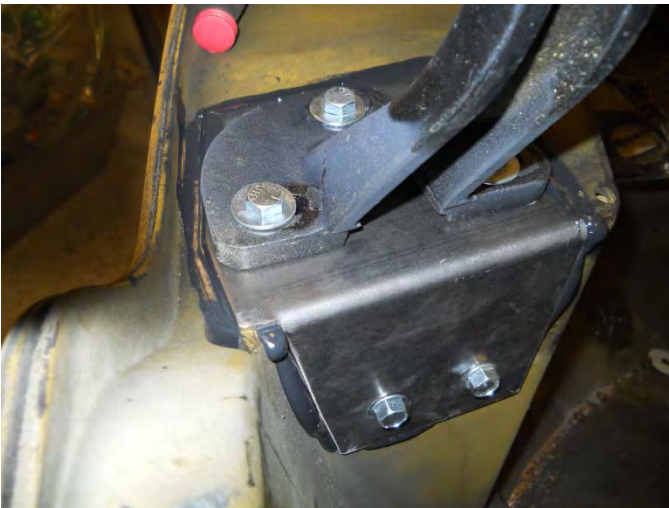
Figure #5

Coat the hood where the plate will mount liberally with the Manus Bond provided and set the plate in place. Install the 3 new hood hinge bolts provided and reinstall the 2 PK bolts (Figure #5). Allow the Manus bond time to set.

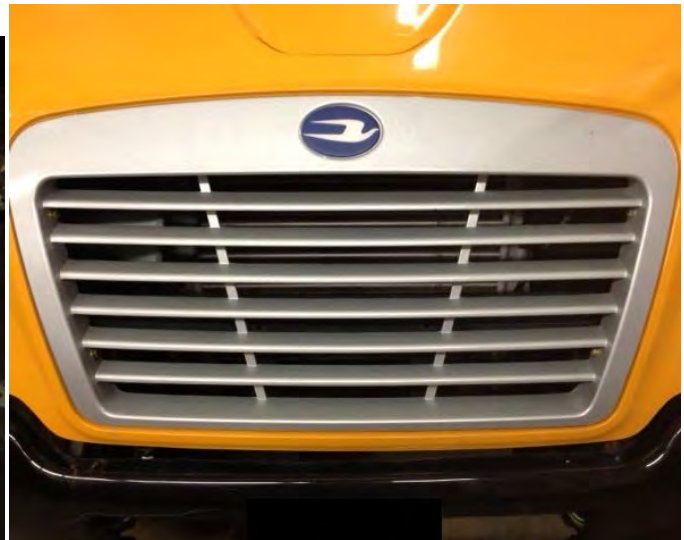
Figure #6

Re-Install hood and adjust as needed (Figure #6)

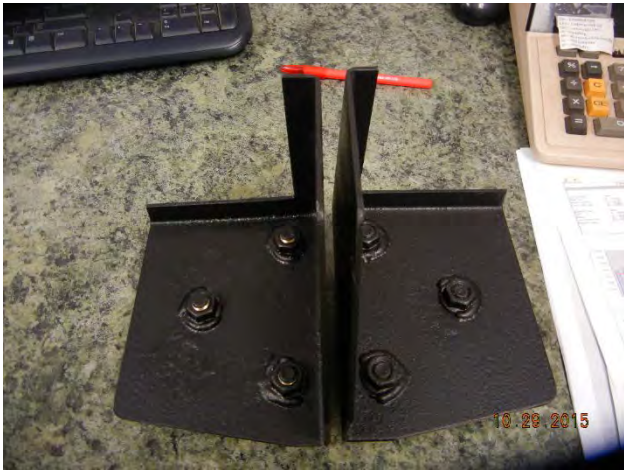
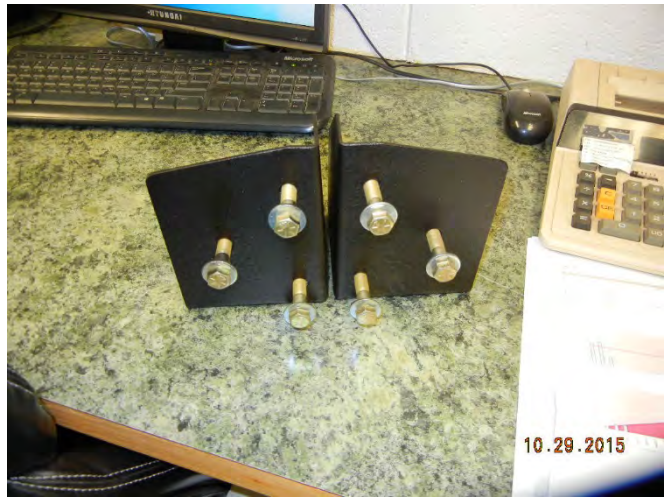
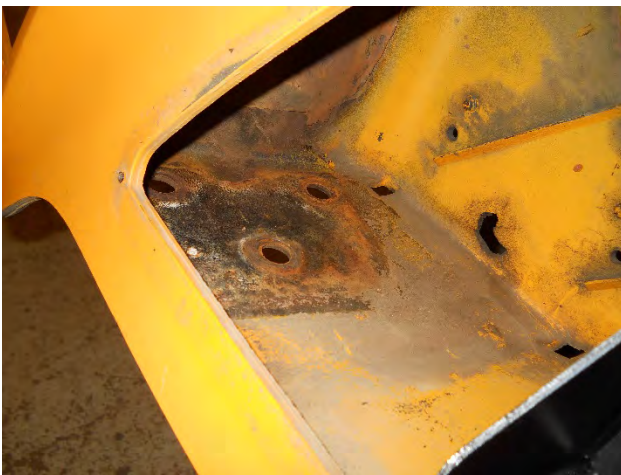
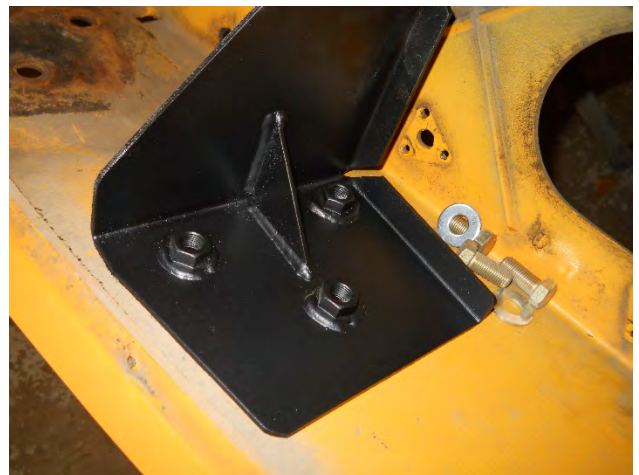
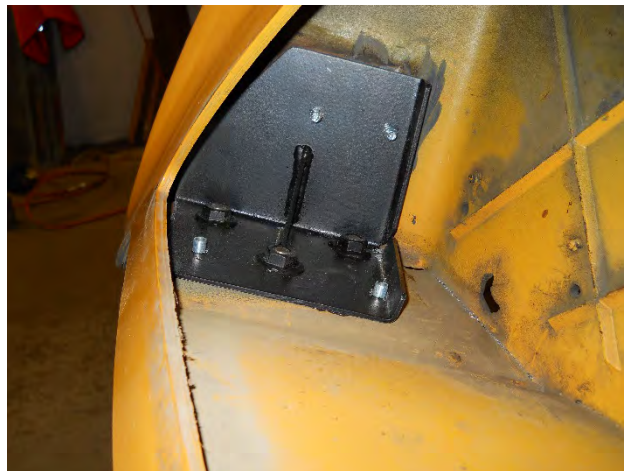
UPDATE – 12/15/15: Recently brought to our attention was the fact that some units, if not addressed in time, have seen issues with the braces inside the headlight housing opening. We now offer a replacement for those hoods that have further issues...please see below

UPDATE – 1/4/2016: New York Bus Sales now has available a “refurbished” hood that has been checked, had all the updated repairs done, painted and ready to bolt on your unit. Your hood must be repairable and returned to us as it will be “refurbished” for other customers as required.
