Micro Bird Stop Arm Camera Removal

Service Update #24-0923

How to Properly Address Removal of a Stop Arm Camera

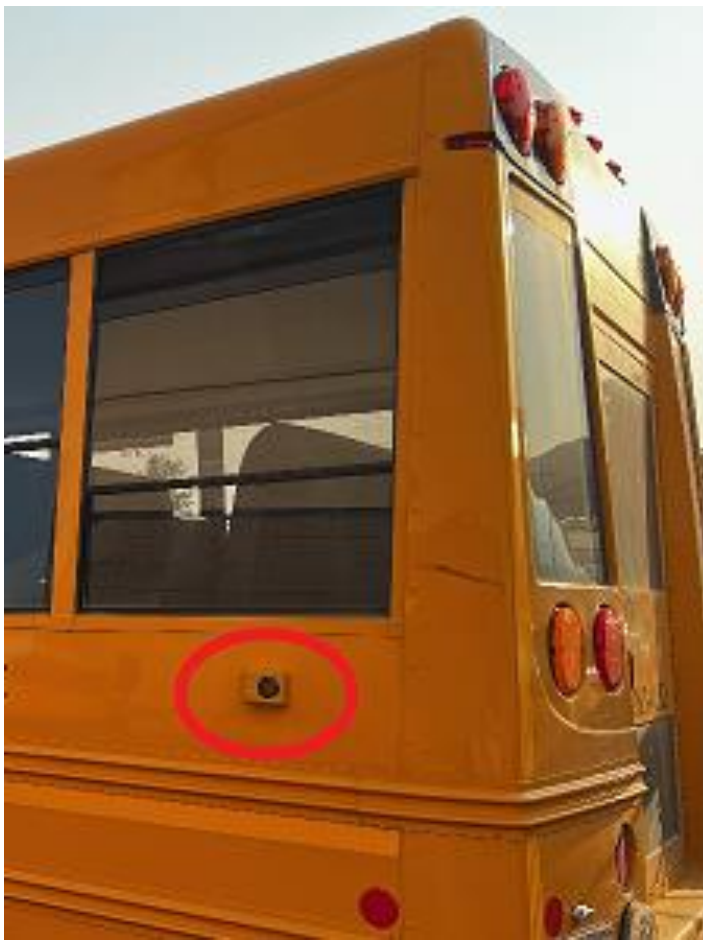
FIGURE #1

We were contacted concerning the removal of a stop arm camera which had been installed just below a window section on the exterior of a unit. (FIGURE #1).

NYSDOT requested a procedure from the manufacturer seeing the camera was installed in a panel of the passenger compartment on the Type A as opposed to the skirt panel on the Type C and Type D units.

- Remove camera
- Sand skin around hole
- Cut a square of aluminium skin bigger than the hole making sure that the portion against the bus has also been sanded.
- Square must be larger than the hole and should be pre-painted yellow.
- Glue the square patch with structural glue (be generous) and rivet aluminium plate to skin.
- Retouch rivets if the rivets used are not already yellow.
- The exterior skin is not considered as the passenger compartment.
