Tech Tip

BBCV Radiator Isolators

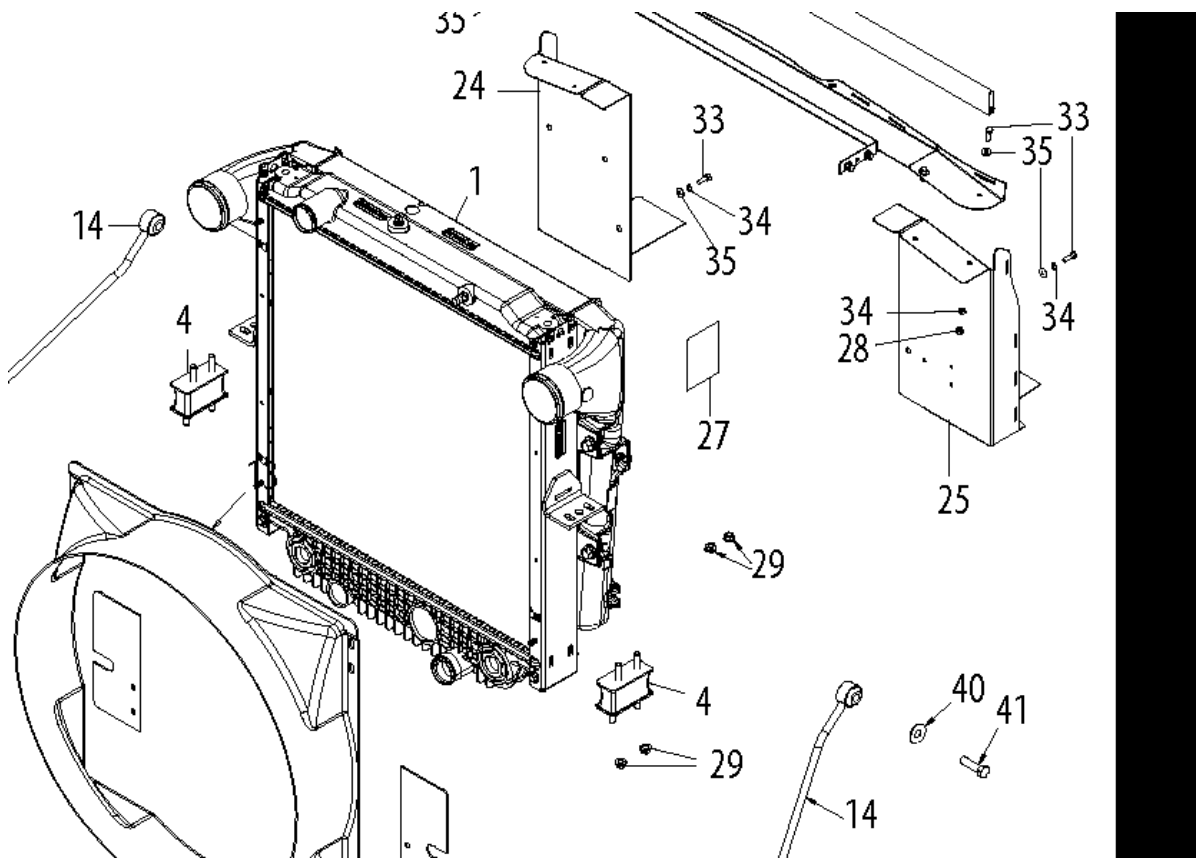
- Complaint –** There is a clicking noise in the front end especially on turns.
- Cause –** On older units we have seen the side mounted radiator isolators, #4 in FIGURE #1 for Diesel units and #3 in FIGURE #2 for Propane units, come apart causing the radiator to “lift” in turns and then settle back down, which may cause the “clicking” noise in turns. Looking at the unit during a normal PM you would not notice that there was any issue. If they have separated they could separate as shown in FIGURE #3.
- Correction –** During PM inspections lifting on the radiator or at the isolators on the frame rail to assure they have not split will ensure there are no issues. If they have split it would be recommended to change both to ensure no further problemsa new one is shown in FIGURE #4
