Tech Tip

BBCV Front Body Mount

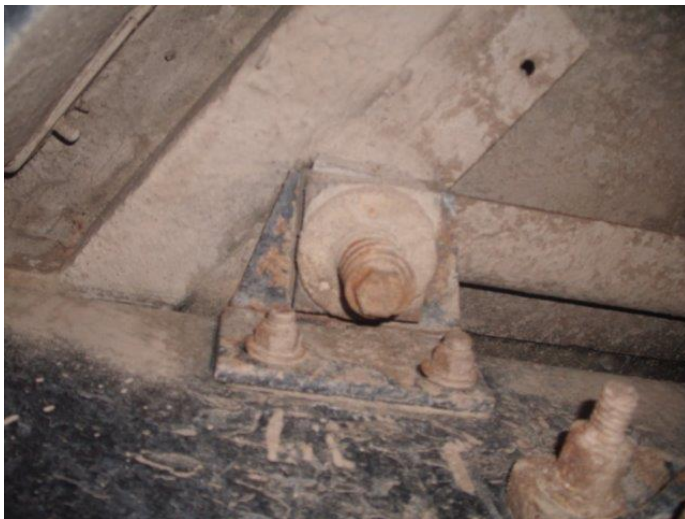
- Complaint –** Driver complained that there was a loud “cracking” noise coming from in under the floor in under the firewall-
- Cause –** The angle mount that bolts to the chassis on the frame rail and then mounts to the body at the front outrigger (#16 in Figure #4) is broken. As you can see in Figure #1 the break may not be clearly evident. Figure #2 shows one which is clearly evident. Figure #3 shows one that has been removed.
- Correction –** Replace the broken bracket-
