Tech Tip

Product Effected –All American “D3”

Complaint: *Driver’s are complaining of cold air in the driver’s area.*

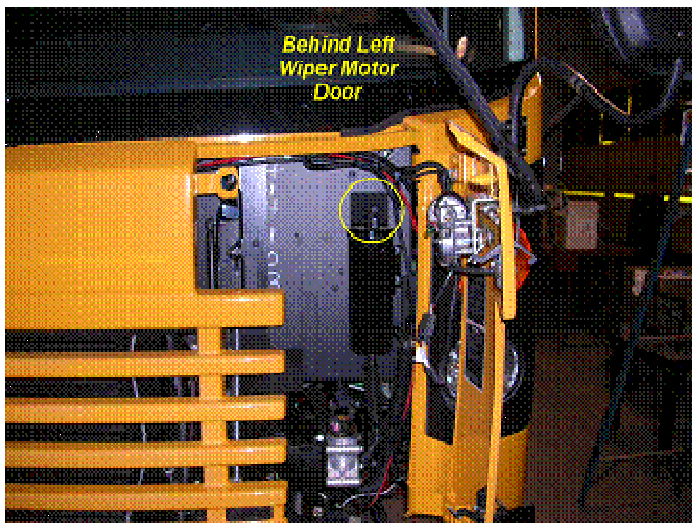
Figure #1

Correction: *Quick check is to open the left wiper door (Figure #1) and look directly above and behind the power steering reservoir (Figure #2) to see if the vent is open.
If it is found to be open there is a vent lever just to the left of the steering column just in under dash (Figures # 3 & #4) which operates the vent.*

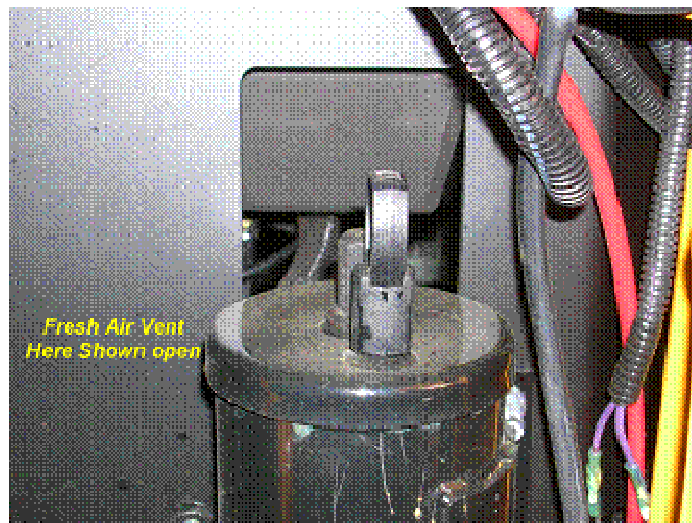
Figure #2

Cause: *There is a “Fresh Air Vent” located in the driver’s compartment which may be open.*
