# Tech Tip

## Blue Bird BBCV (Vision)/GM 8.1L Propane Engine w/single serpentine belt

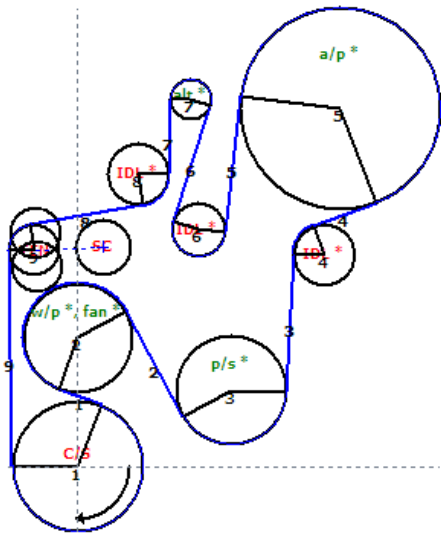
**PLEASE NOTE –** Figure #4 also gives the proper belt routing-

After replacing the belt and tensioner as previously discussed it was determined that the tensioner would again be running too close to the nubs which was not recommended. Working with Dayco it was determined that idler #6 in the **Figure #4** should be replaced with a slightly larger pulley, Dayco #89106. Once this is done and the unit ran for a couple of days you can see that the tensioner is almost perfectly centered as it should be.
