## Side Emergency Door – Luggage Door Obstruction Tech Tip #15-1001REVB

## **Side Emergency Door-Luggage Door Obstruction**

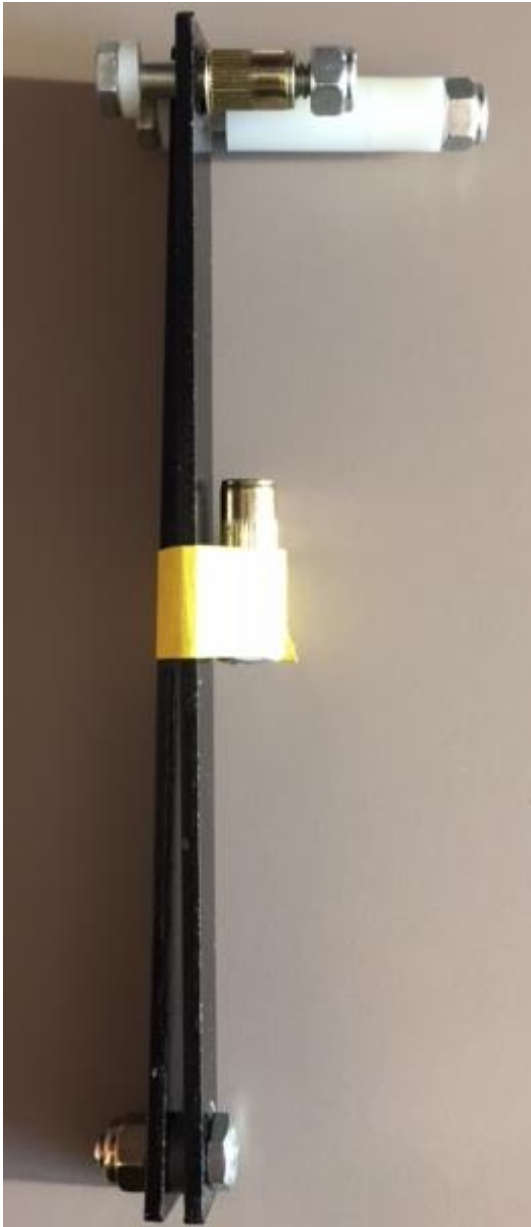
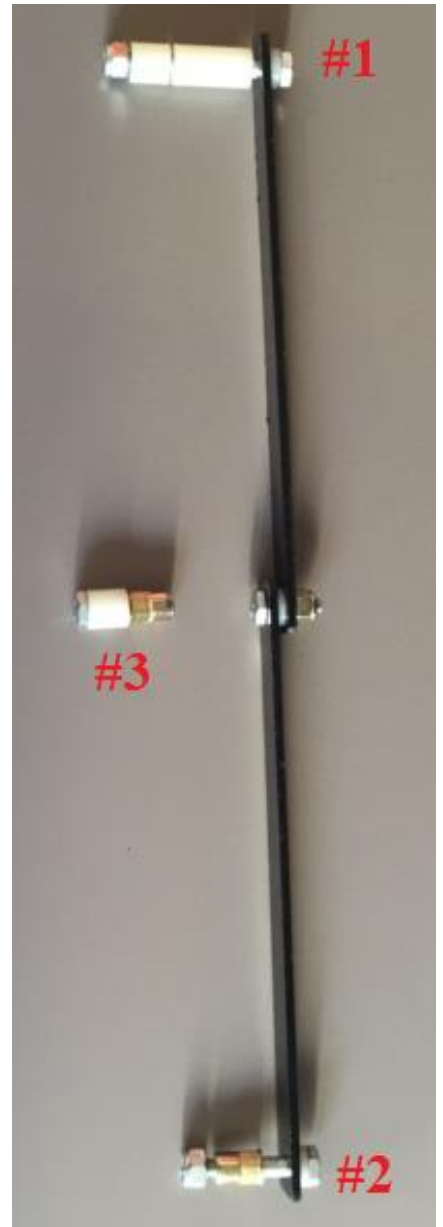
The unit comes assembled as in the photo below on the left. Removing the tape there is a nut sert , plastic bushing and ¼ X 1 (STOP) bolt separate from the assy. #3 in the photo below on the right.

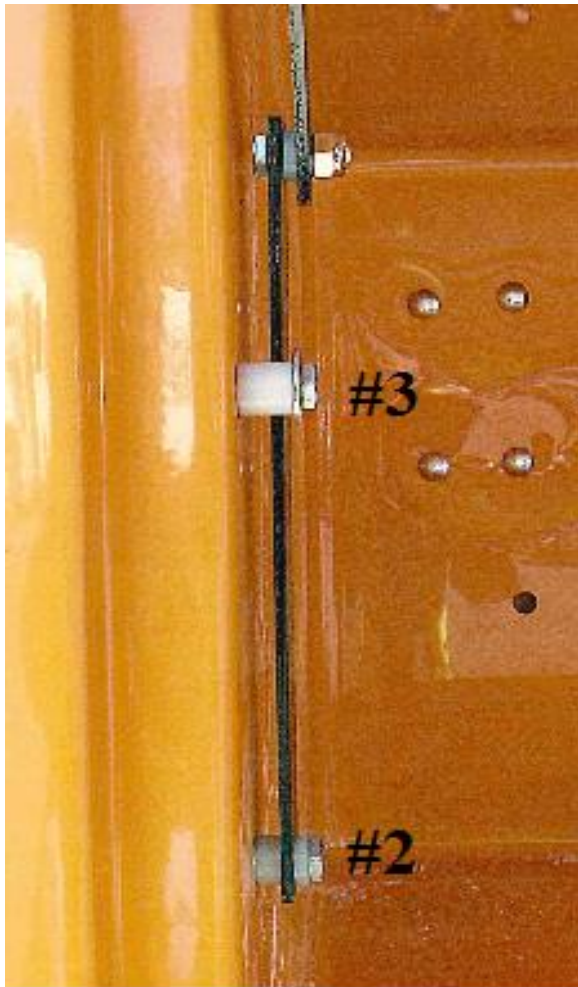
Step #3 – Install the lower pivot bolt with the nylon washer between the arm and the nut sert, Tighten so that the arm moves freely on the bolt but is not sloppy and then install the locknut in the bolt on the outside of the box to avoid having the bolt back out. Item #2 in the photo to the left below.

Step #4 – Install the “stop” in the upper nut sert with the nylon spacer as shown at #3 in the photo to the left below.

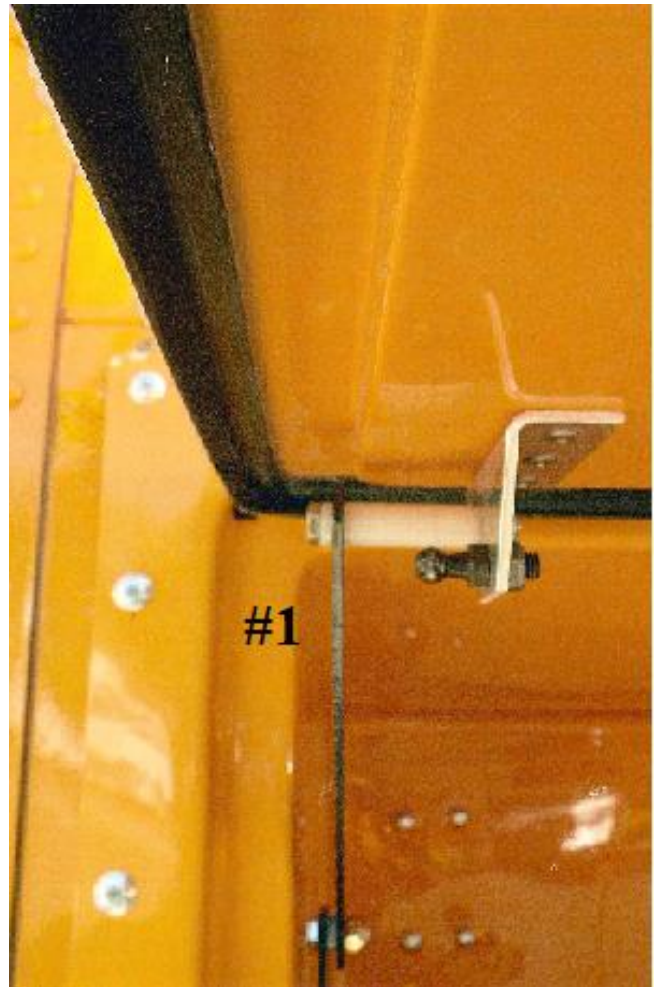
Step #5 – Hold door to just under 90\* and hold upper mount on shock bracket of the door, drill a 17/64” hole and install bolt with nylon spacers and lock nut as shown at #1 of photo below to right.

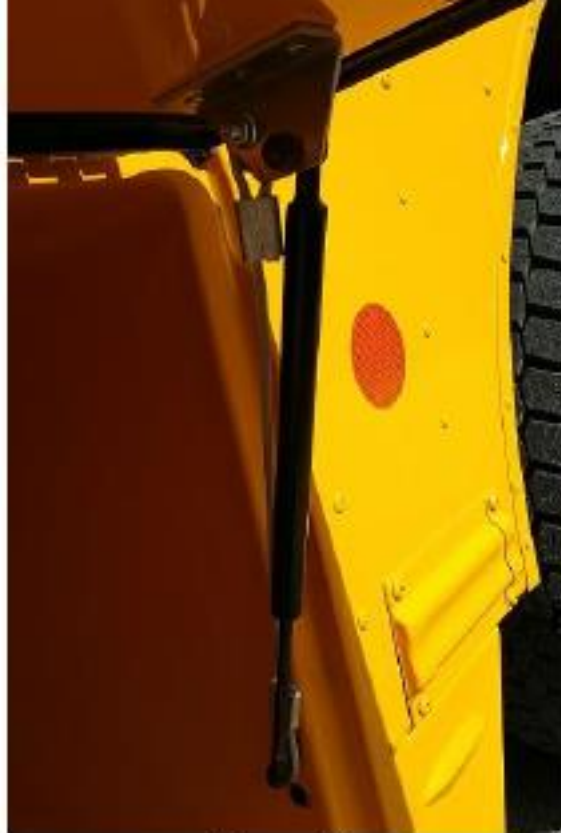
**Figure #1**

Below Figures #1 & #2 show the strut which holds the luggage doors open on our fiberglass luggage. As you can see we have added a cable to limit the travel by wrapping the cable around the lower pivot of the strut and then using one of the bolt holes in the door bracket and a fender washer. Limiting the the travel assures the luggage door does not travel the full stroke and obstruct the side emergency door, see Figures #3 & #4

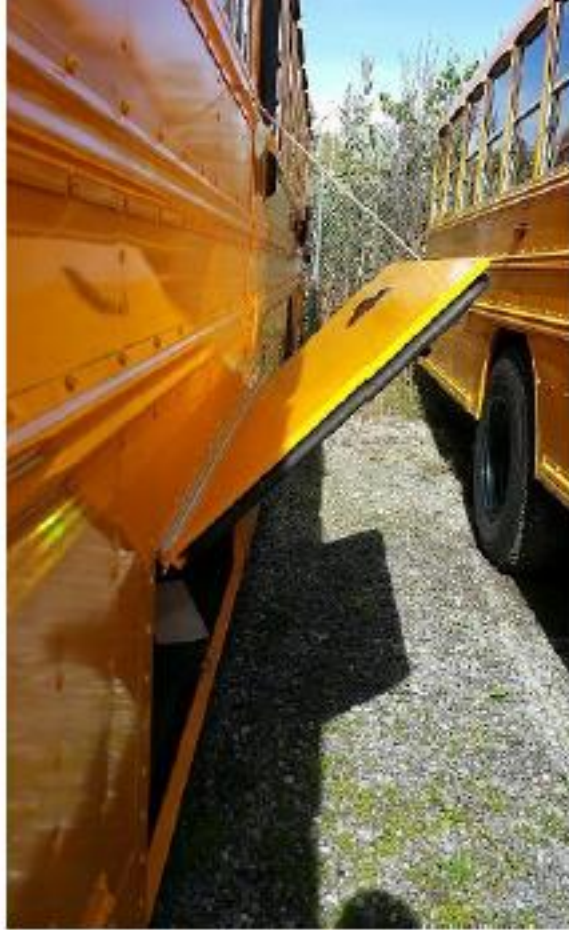
**Figure #5**

Figure #5 below shows the luggage door on a Rear Engine unit as presented from Blue Bird, their doors are held open by a cable attached to the door and a holder mounted on the body. Making a longer cable will allow the door when opened to be adjusted so it does not obstruct the side emergency door, see Figure #6

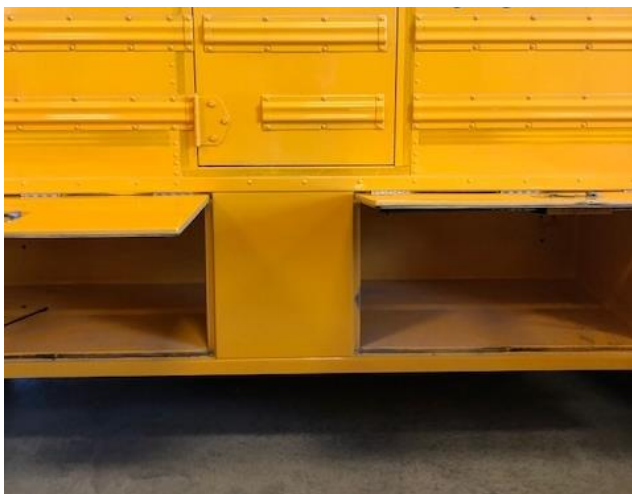
They have researched to find a gas strut replacement with the proper length to keep the door at a 90\* opening. FIGURE #1 shows the open doors on a unit where the new gas strut is used on the left door and our previous method was used on the right door. FIGURE #2 shows our previous “hold open” device unhooked, and the new strut mounted using the already installed hardware. FIGURE #3 shows the strut, which is part #4683.

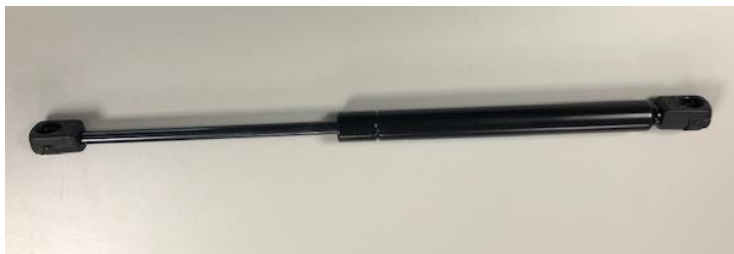
FIGURE #3

**New Strut**  
**Part #4683 List \$22.17**
