NEW YORK BUS SALES

Tech Tip 16-0207-1

2014 and Newer BBCV Headlight Aiming

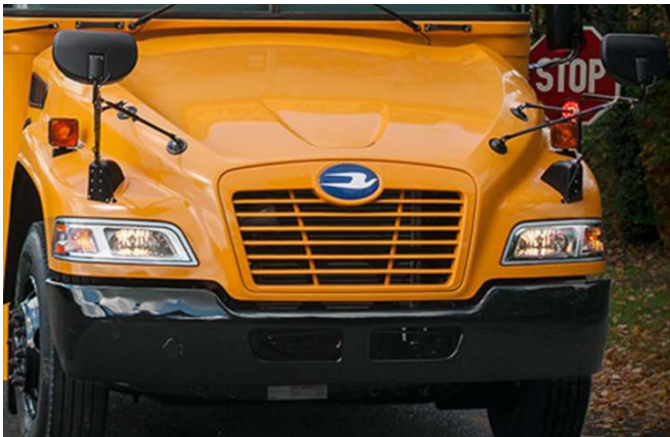
Figure 1

Cause: The newly designed hood with the “molded” headlights (Figure 1) does not have any “apparent” adjustments.

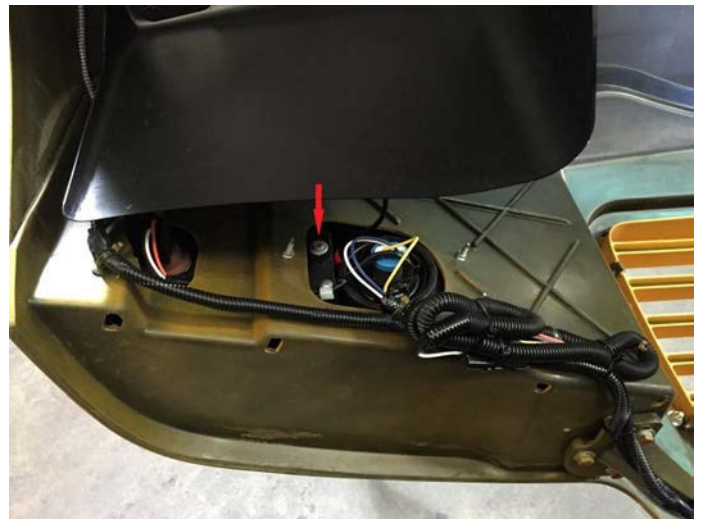
Complaint: Driver says the headlights point up or down and need to be aimed.

Correction: Tilting the hood and looking behind the light in the cutout of the hood you see 2 screws. The upper screw pictured in Figure 2 is the adjustment for up & down and is the only adjustment. The light itself takes care of right and left aiming.
