Tech Tip

FROM YOUR FRIENDS AT
NEW YORK BUS SALES!

Blue Bird BBCV (Vision)/GM 8.1L Propane Engine w/single serpentine belt

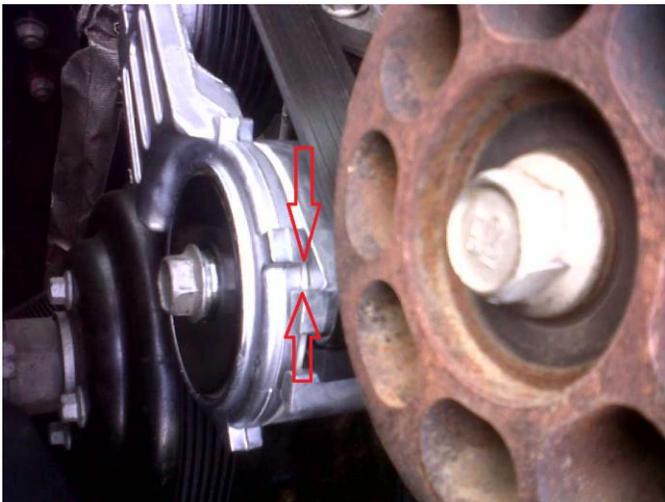
- Complaint –** The belt tensioner nubs are running too close showing that the tensioner +/- or belt are worn. A slight “chirp” may be heard on shutdown of the engine – Please see Figure #1 & 2.
- Cause –** If the belt or the tensioner has recently been replaced it may be the improper part, if not the belt +/- or tensioner may be worn.
- Correction –** If the belt +/- or tensioner have recently been replaced and the “nubs” of the tensioner are still close you need to make sure that the proper parts have been used. See the text box below-

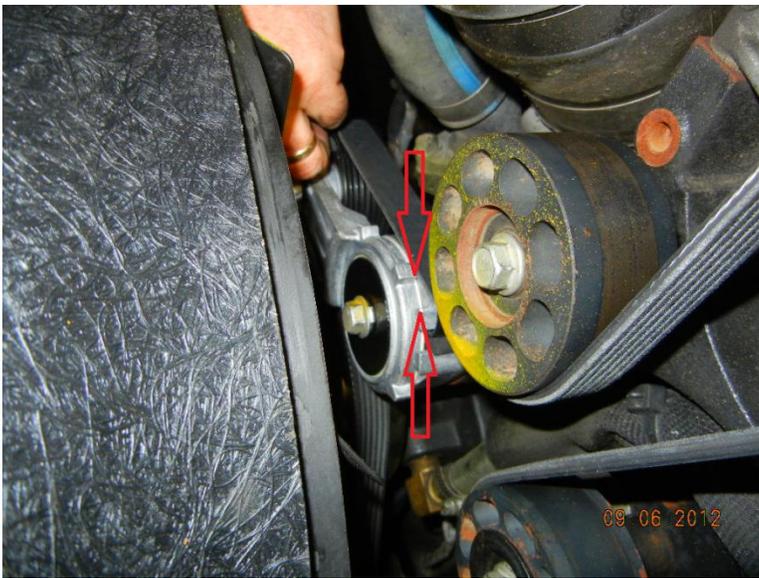
Figure #3

PLEASE NOTE – After checking with Dayco who provided the belt set-up on this unit there should be 14 degrees between the nubs of the tensioner which equates to approximately 1/2” as shown in Figure #3.

PROPER PART NUMBERS

TENSIONER PART #1622-6300-01

BELT-DAYCO PART #5061360
